Manhole Inspection Summary

Manhole # S13W__012MH

Insp Date: **1/9/09 2:05 PM**

Location Address: **Wilmarco Dr.**

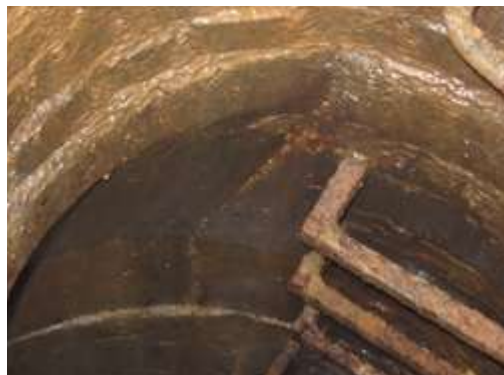
Defect 8

crack in corbel with infiltration

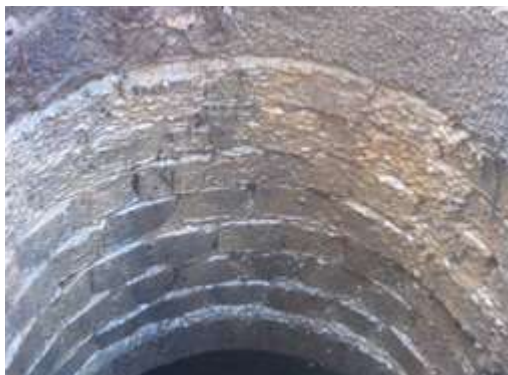
Defect 7

chimney infiltration

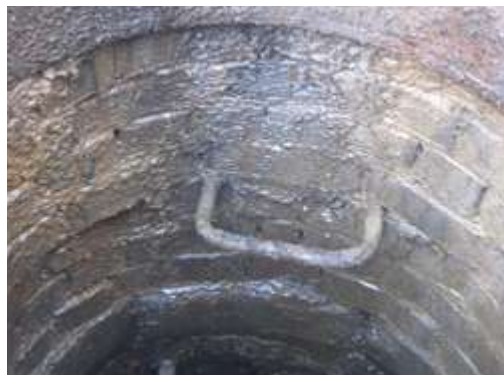
Defect 6

frame leaks,missing mortar at chimney causing infiltration

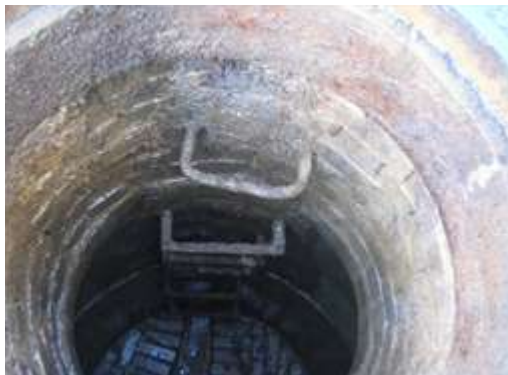
Defect 5

active infiltration at chimney

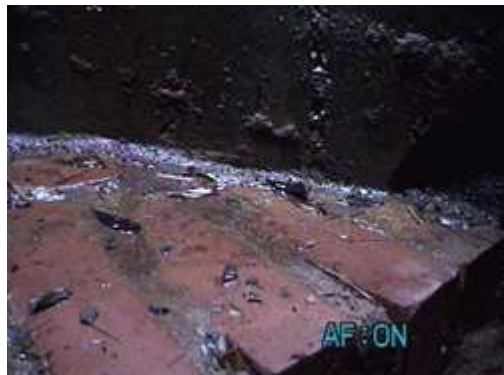
Defect 4

barrel infiltration

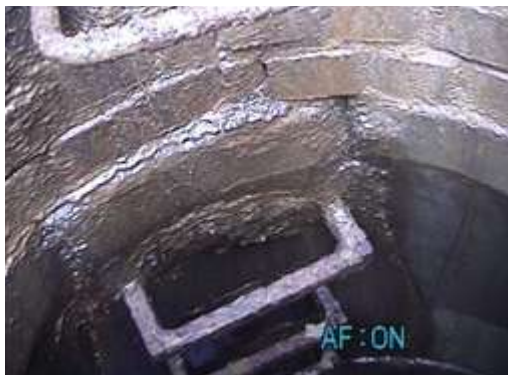
Defect 3

corroded rungs and corbel infiltration

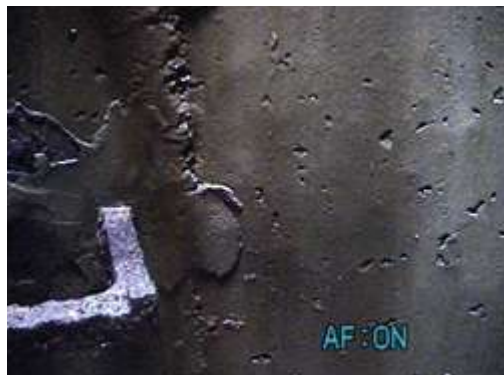
Defect 2

crack in barrel with infiltration

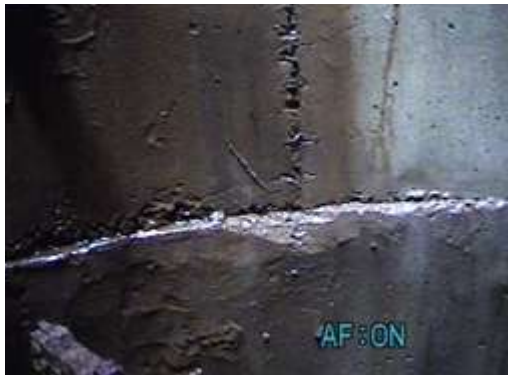
Defect 1

corbel infiltration at crack and joint

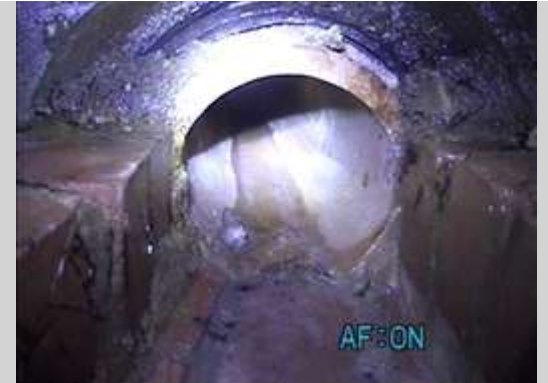
12 O'Clock Outflow

6 in. Circular Gravity Sewer
Pipe Out @ 12 O'Clock

Pipe Height: **6** (in.) Rod and Bar (Angled)
Pipe Material: **Clay** ☐ Pipe Lined
Invert Depth: **9.43** (ft.) Flow Characteristics: **Slow**
Deposits: ☒ None ☐ Mud ☐ Sludge ☐ Debris ☐ Grease
Silt Depth: **0** (in.) Deposits Extent:
Infiltration: **Evidence** Pipe Seal Cond: **Sound**
